REPORT OF SAMPLING ACTIVITIES

RICO-ARGENTINE MINE

RICO, COLORADO

TDD R8-8411-02

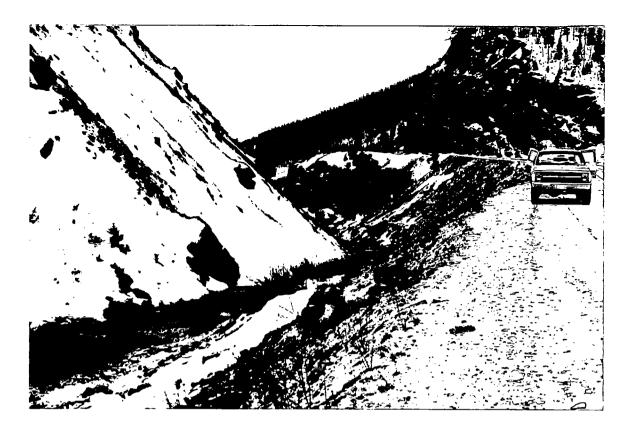
PHOTO 1: LOCATION OF UPGRADIENT SURFACE WATER SAMPLE, RA-SW-5, ON THE DOLORES RIVER. VIEW IS TO THE SOUTH. HORSE CREEK IS APPROXIMATELY $\frac{1}{2}$ MILE TO THE SOUTH.

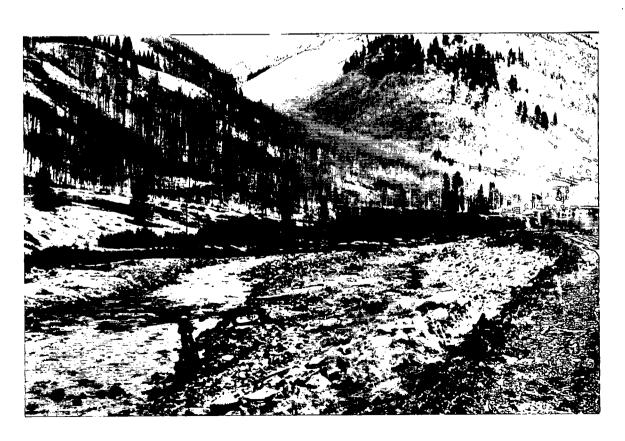
PHOTO 2: LOCATION OF SURFACE WATER SAMPLE RA-SW-6 ON THE DOLORES RIVER ADJACENT TO SETTLING PONDS ON THE RIGHT. NOTE STAINING ON ROCKS BELOW PONDS. VIEW IS TO THE NORTH.

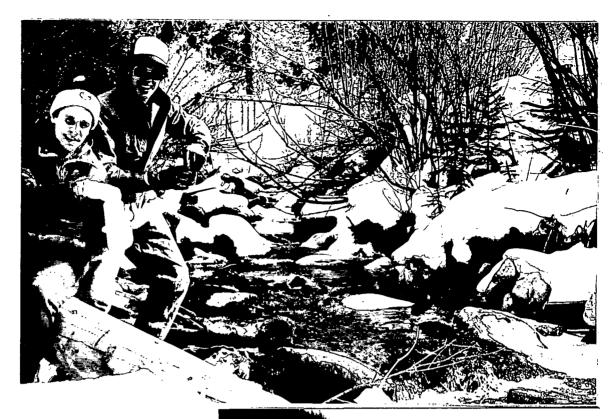
PHOTO 5: (ABOVE) LOCATION OF
UPSTREAM SURFACE WATER
SAMPLE RA-SW-1 ON SILVER
CREEK. GREEN BUILDING
IN BACKGROUND NOTES
LOCATION OF TOWN WATER
SUPPLY.

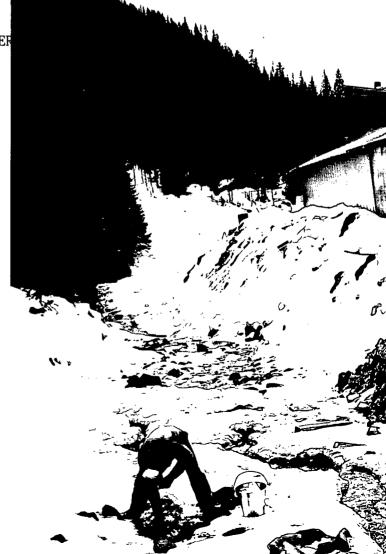
PHOTO 6: (RIGHT) LOCATION OF SURFACE WATER SAMPLE RA-SW-2 TAKEN DOWN-STREAM OF BLAINE TUNNEL DISCHARGE ON SILVER CREEK.

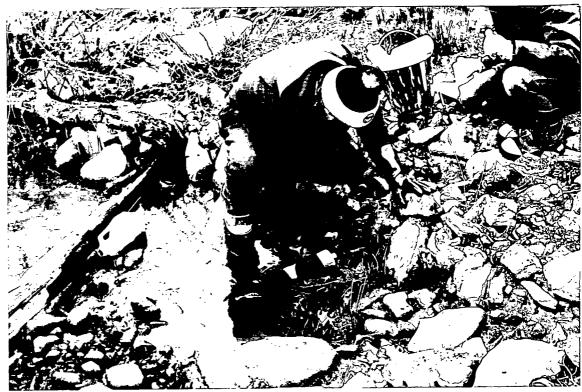
PHOTO 8: (BELOW) LOCATION OF SURFACE WATER SEEP SAMPLES RA-SW-4 AND RA-SW-10 SHOWING CLOSE-UP OF IRON STAINING.

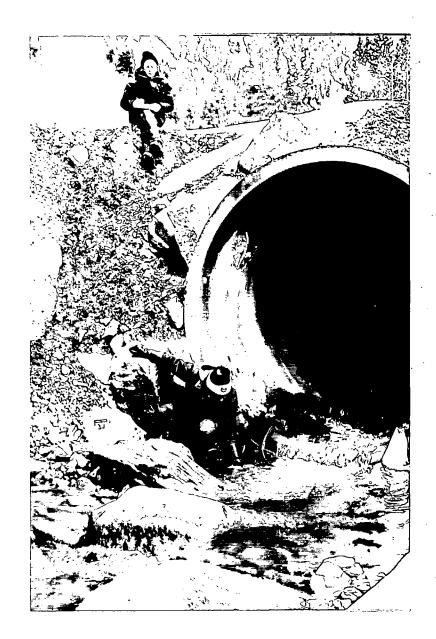
PHOTO 9: LOCATION OF SURFACE WATER SAMPLE RA-SW-3 TAKEN DOWNSTREAM OF TAILINGS PONDS ON SILVER CREEK.
